# Manhole Inspection Summary

## Manhole # S17GG1012MH

Insp Date: **4/3/07 12:52 PM**

**Location** Address: **4104 GREENSPRING AVE**

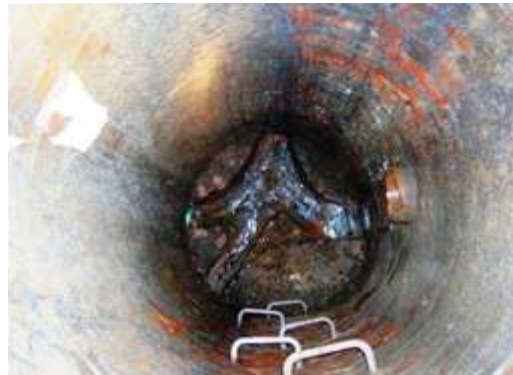
Top View

Bench and Channel debris.

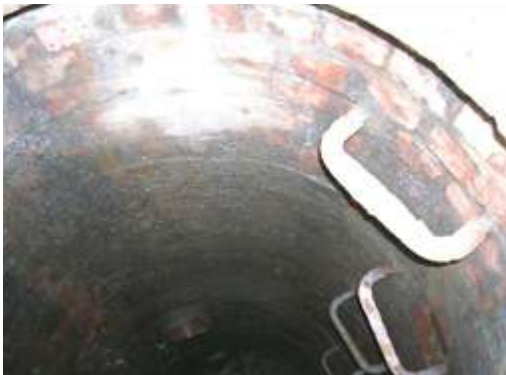
Defect

Frame leaks. Adjustment, Corbel and Barrel infiltration.

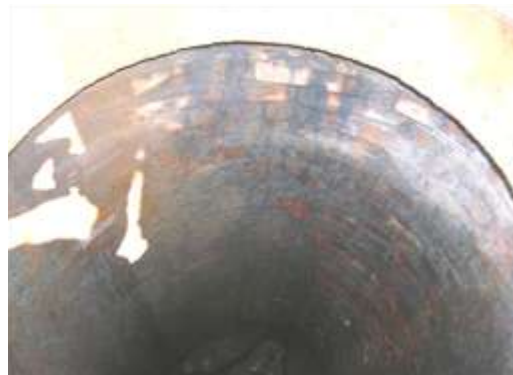
Defect

Frame leaks. Adjustment deterioration and infiltration. Corbel and Barrel infiltration - other side.

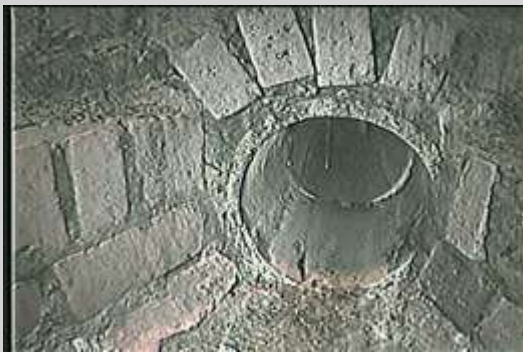
### 8 in. Circular Gravity Sewer Pipe Out @ 12 O'Clock

Infiltration: **Evidence** Pipe Seal Cond: **Unknown**

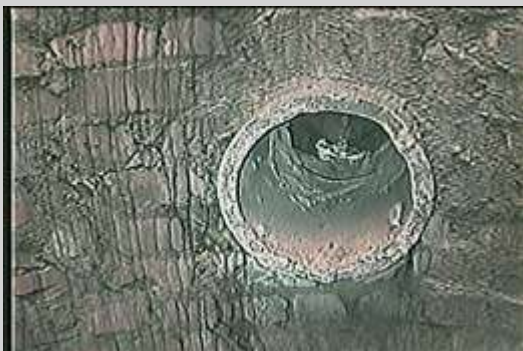
### 8 in. Circular Gravity Sewer Pipe In @ 3 O'Clock

Deposits: ☐ None ☒ **Mud** ☐ Sludge ☒ **Debris** ☐ Grease

Silt Depth: **1** (in.) Deposits Extent: **Light**

Infiltration: **Evidence** Pipe Seal Cond: **Unknown**

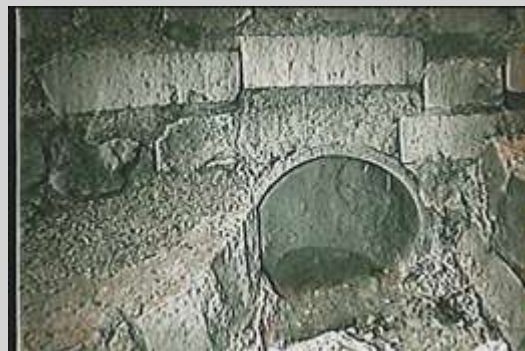
### Drop In @ 3 O'Clock

Barrel deterioration and infiltration. Channel deterioration.

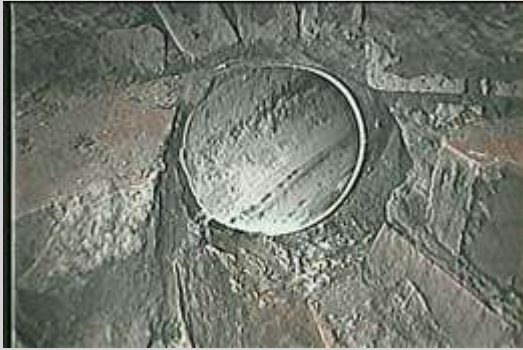
Pipe In @ 7 O'Clock

Infiltration: **Evidence**

Pipe Seal Cond: **Broken**

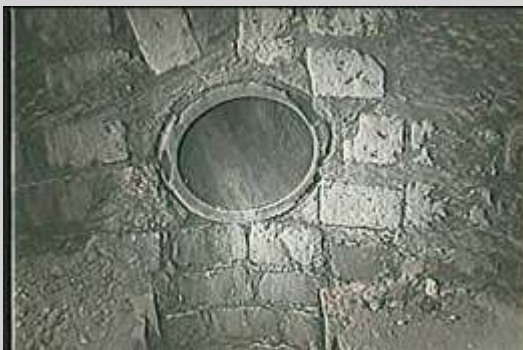
Pipe In @ 10 O'Clock

Infiltration: **Evidence**

Pipe Seal Cond: **Cracked**
